# Stream Restoration as a Method of Improving Local Water Quality

Emily George

December 15, 2019

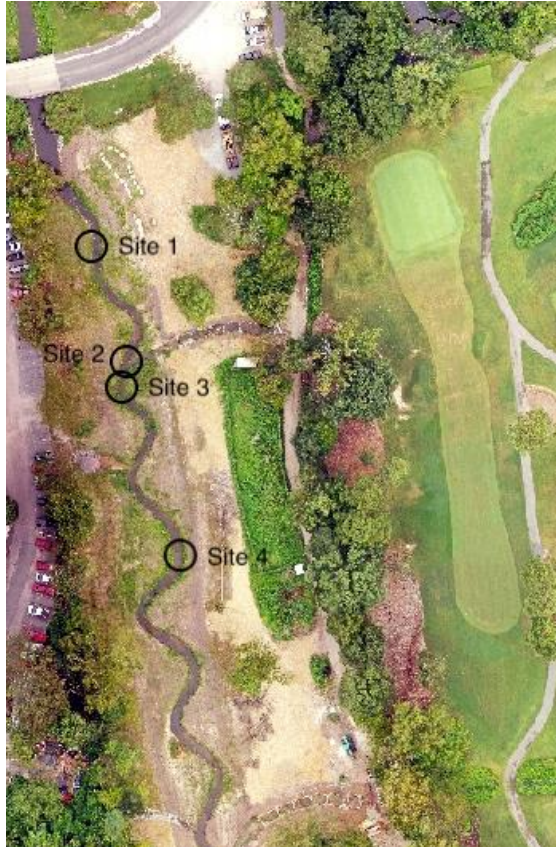
**Figure 1 (below, left).** Site 1 represents water flowing through LWC from Westhampton Lake. With little time for hydrological components of LWC to filter out any incoming nutrients from the lake, this sample should be an accurate representation of the quality of water as it enters LWC. Site 2 samples water taken right at the step pool, which acts as a buffer for water entering from the golf course. Site 3, samples water taken just after the step pool. Water from Site 4 was taken from farther downstream LWC, representing the water quality after various assets of the stream, before flowing through the bioretention pond and into the greater watershed.

The sampling of N and P in this study showed a decline in nutrient concentrations between site A and site D. The location of samples was purposeful, and the results indicated that the assets throughout the stream may have a positive impact on water quality. Another study found that concentrations of N and P decreased from the inlet to the outlet of the stream, suggesting that the stream was effective in reducing nutrient levels (Thompson et al.). The two sequences of step pools act to slow the flow of water, which results in longer retention time and allows for nutrients to settle out of the water. In conjunction with the increased sinuosity of the stream, the flow of water is slowed, also allowing for nutrients and sediment to precipitate out. The bioretention ponds farther downstream aid in this process as well.

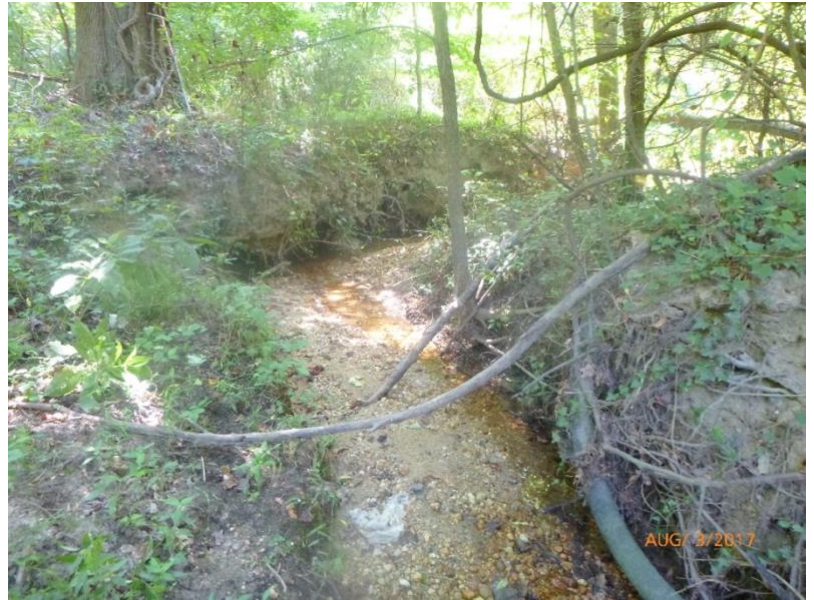
**Image 1 (above).** LWC pre-restoration shows high, steep streambanks, a wide channel, and although not as visible in this photo, follows a straight path with little variation.

BEHI levels pre-restoration showed that the majority of areas measured as high or very high regarding risk of erosion. BEHI values are based on various measurements and functions of the stream such as bankheight, bankfull root depth and density, and slope steepness, and the index values of a “healthy” stream should all show low BEHI, indicating that the streambanks are in great condition at this point post-restoration (Rosgen 2001). As time goes on, the values will likely change, showing progression, but should consistently demonstrate acceptable BEHI indices along the length of LWC. Although post-restoration data has not yet been processed, based on the proposed and observable structure and hydrology of LWC after construction, I would expect BEHI levels to have decreased from pre-restoration states (see Images 1-2 below).

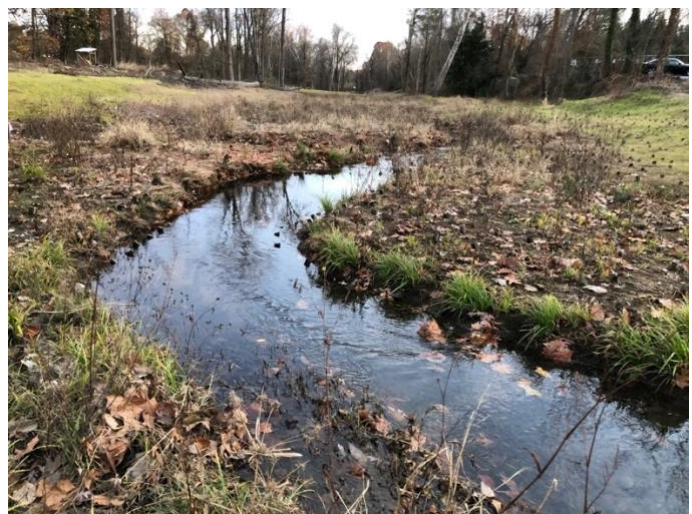
**Image 2 (right).** Post-restoration, LWC is characterized by thinner channels and much shallower streambanks, and meanders throughout the Eco-Corridor.

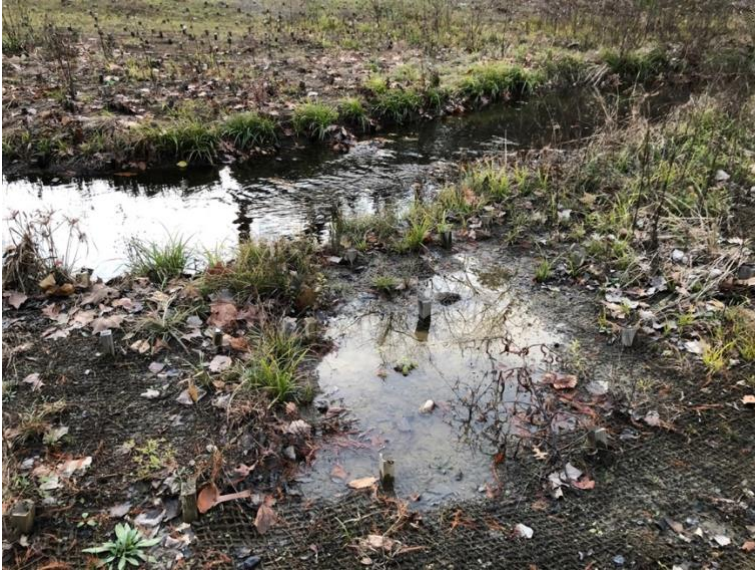
**Image 3.** Showing LWC's new connection to the floodplain, as water spilled its banks after a rain event.

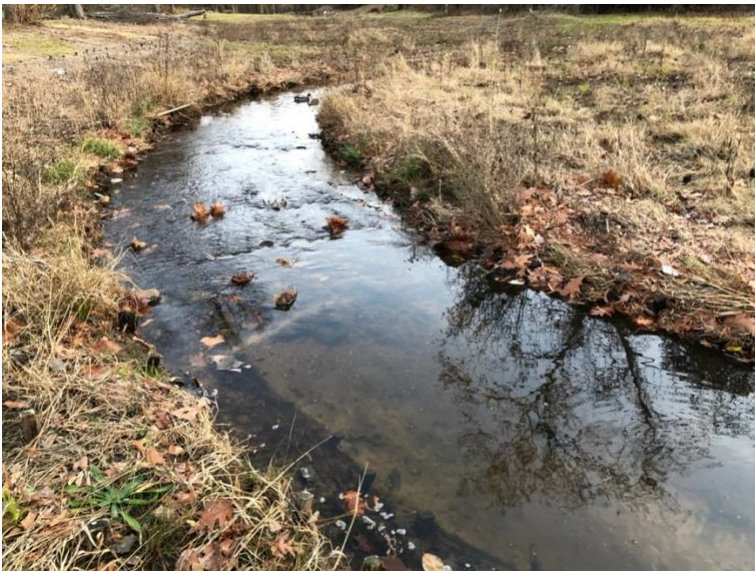
**Image 4.** A point in the stream with a deeper thalweg leading into a higher flowing point in the stream. The deeper part of the stream will act as a small retention pond, allowing time for nutrients and sediment to precipitate out of the water and settle to the bottom of the stream.
