Senior capstone- final paper

Tree removal analysis of the 2018-2019 Gambles Mill Eco-corridor restoration

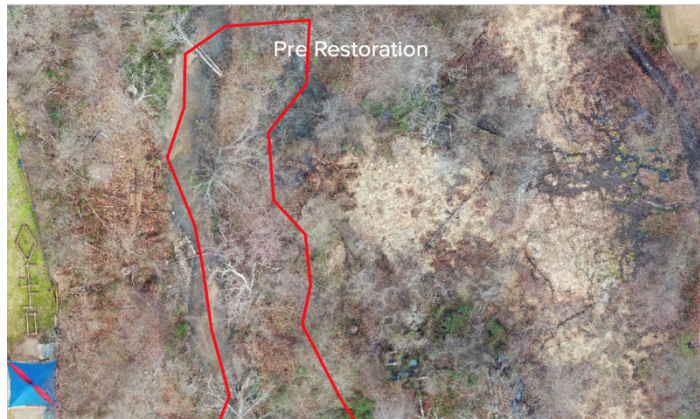
Image 1: Pre-restoration drone imagery, georeferenced, and zoomed in for ease of comprehension within ArcMap.

As indicated through the red polylines in the images below (*Images 1-3*), this is the process that was carried out through this analysis. By clicking through the georeferenced images on ArcMap, you user is able to see the differences in the orientations of the landscape. As can be seen on the first image (*Image 1*), the user can vaguely make out the trees present in the landscape before the restoration. Then by referencing it to the second image (*Image 2*), the georeferenced blueprint, it becomes a bit clearer what trees are actually present in the image.

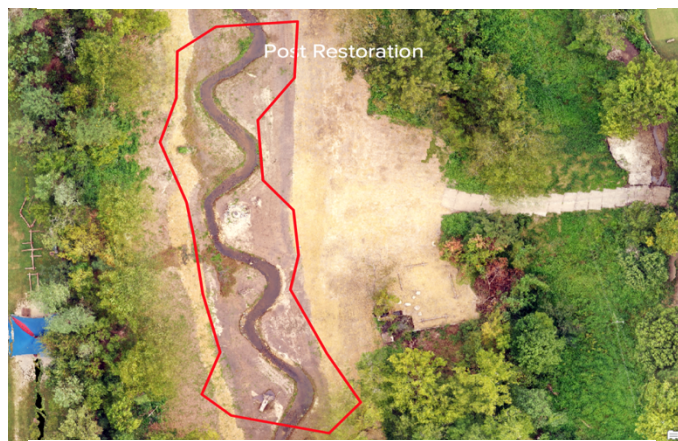
Image 3: Post- restoration drone imagery, georeferenced, and zoomed in for ease of comprehension within ArcMap.

Finally, by switching to the georeferenced post restoration drone image (*Image 3*), it is clear which trees were actually left and which were taken out. This process was completed and repeated until all 291 trees within the polygon were accounted for.

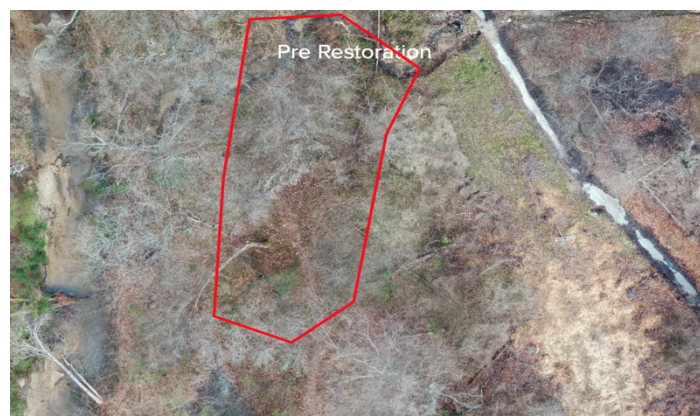
Image 4: As can be seen, the pre-restoration drone image was very difficult to comprehend.

This analysis and its results were at the expense of a few limitations. Given the season and the day that the pre-restoration image was taken, it was very hard to comprehend the actual contents of the image. The image was taken in the late winter (February), with all of the plant life mostly dead and brown and the trees bare, and in amalgam with the image being not the highest resolution, and the eco-corridor being very overgrown before the restoration took place, the image was nearly useless for certain areas of the analysis (*Image 4*). But the blueprint was very useful for the most part in the completion of this analysis. The highlighted trees were much simpler to identify their presence. The trees in grey circles were much tougher to analyze given their groupings, and it seems they may have less accurately depicted on the blueprint (*Image 5*). As you can see in the pictures provided, in the blueprint within the red line polygon, there is a grouping of trees signified by the grey circles. But it is evident in the post restoration imagery that the grouping of trees is not there, but there is a grouping a bit to the left that is not accounted for in the blueprint. Then, in the pre-restoration image, it is apparent that it is very hard to comprehend in general. These discrepancies made it difficult to offer completely confident results and was a limitation. Regardless, the three images in this analysis were enough to give fairly confident results.

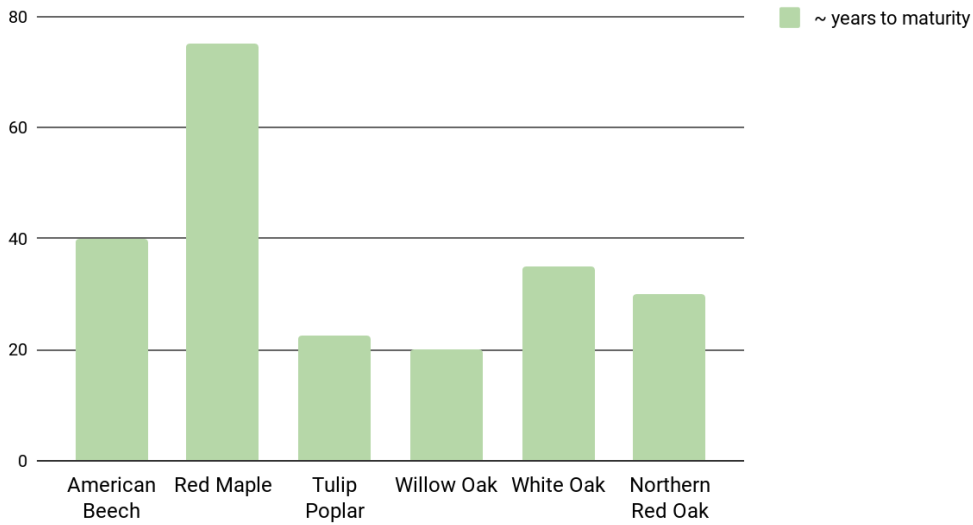
Tree planting's species years to maturity

Figure 2: Depicting the rough estimate of the years to maturity for each respective tree species planted through the restoration.

Then, in regard to the future of the Gambles Mill eco-corridor, scholarly articles identified that it would be roughly 35-40 years until the trees planted generally would be reaching maturity (Hoyt, 2017, Burns and Honkala, 1990, Neal and Whitlow, 1994, Bush, 2018, Bingaman, 2019) (*Figure 2*).
