# **Step Pools: Examining the Flow Resistance and Stability of Artificial Step Pools in Comparison with their Natural Counterparts**

Quinn Kirkpatrick  
12/16/19  
Senior Capstone

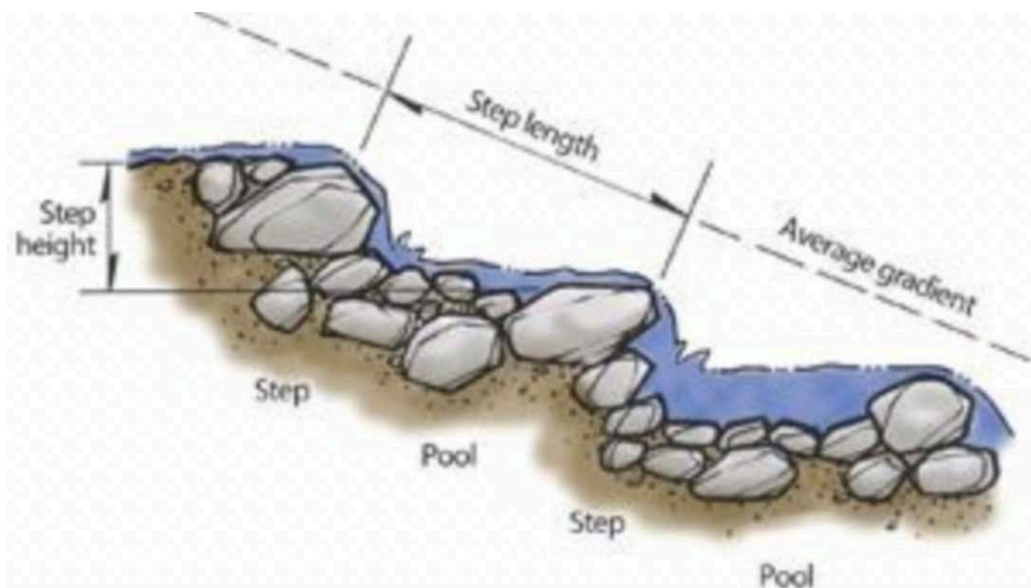
**Figure 1:** Step pool dimensions as measured in the studies used as well as in the field (Moses, 2010).

dimensional measurements of the step pool structures were collected. The dimensions are the average height of the steps (H), the average length of the pools (L), and the average slope (S) of each entire step pool sequence. The measurements used were standard across the step pool studies and are shown in Figure 1. The average height of the steps was defined as the average distance from the top of a step to the surface of the water in the pool below. The average length of the pool was defined as the distance measured from the top of an up-stream step to the top of the next downstream step. The slope was measured by taking the change in elevation from the top step to the bottom step and the length of the step and finding the gradient change between them. From these measurements, the flow resistance H/L/S ratio was calculated for each step pool for comparison and analysis between the step pools and also against the ideal maximum flow resistance range found by Abrahams et al (1995).

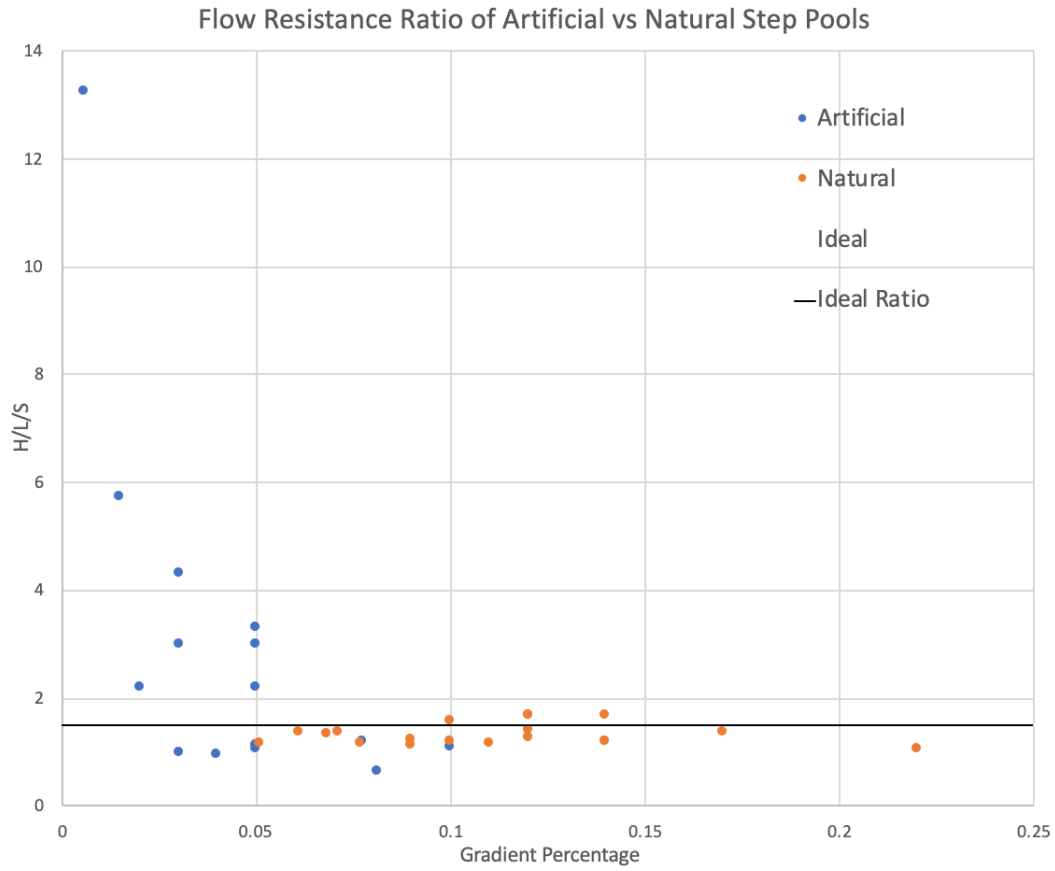
**Figure 2:** This graph compares the H/L/S flow resistance ratios between the artificial and natural step pools. The H/L/S ratio is placed on the y-axis, and the average slope is placed on the x-axis.

The flow resistance ratio differences between natural and artificial step pools are shown in Figure 2. The average slope of each step pool sequence was plotted on the x-axis, and the calculated H/L/S value was plotted on the y-axis (Figure 2). A black line at a ratio of 1.5 represents the average max flow resistance value measured by Abrahams et al (1995) (Figure 2). In looking at the graph, the natural step pools are found at a range of different slopes from .05 to .22, however, they all were found to have similar flow resistance ratios (Figure 2). The artificial step pools, on the other hand, are found at gradients that are no higher than .1, and their H/L/S ratios were found to range from values less than 1 all the way up to 13.26 (Figure 2).
